**Door Difficult To Close –
Blocked Seal Evacuation Holes –
Repair Procedure**

MODEL 2002 MY-ON
X-TYPE

VIN C00001-ON

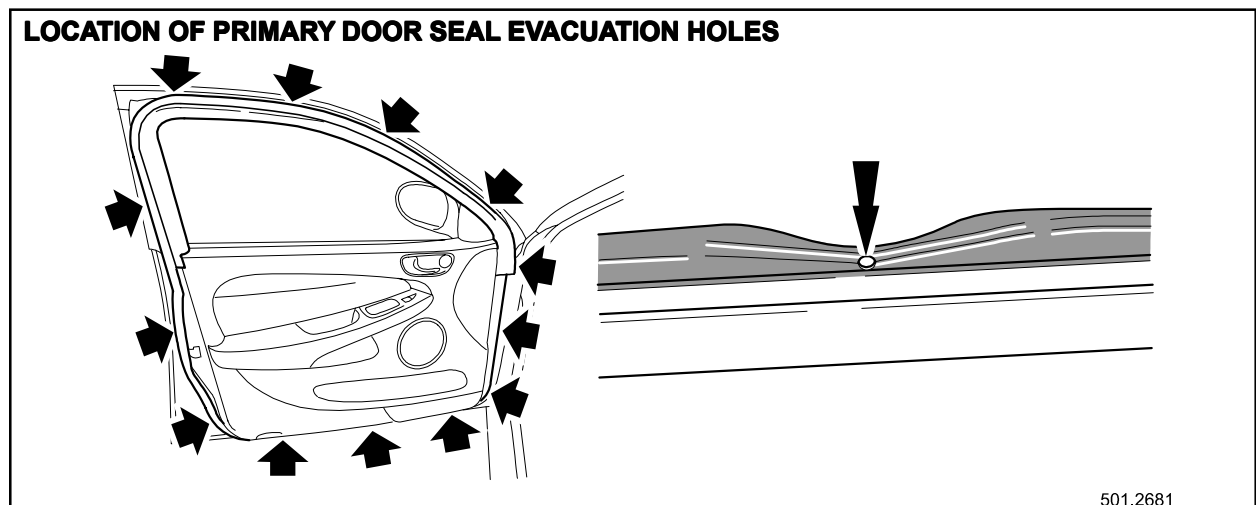
ILLUSTRATION 1

On some 2002 MY-ON X-TYPE vehicles, customers may report excessive effort required to close any or all of the side doors. This concern can be caused by the seal evacuation holes being blocked in the primary (door) or secondary (body side) seals around the door or door opening.

The holes are cut into the seal but the material is not removed from the holes, which may cause the concern. Clearing out the holes will allow the air to escape from the seals on closure.

1. Open left-hand front side door.
2. Check primary door seal evacuation holes, remove any material blocking any of the cut holes (Illustration 1).
