Interior Rear View Mirror (Auto-Dimming) –
Loose Retaining Springs –
Repair Procedure

MODEL 2002 MY-ON
X-TYPE

VIN C00001-ON

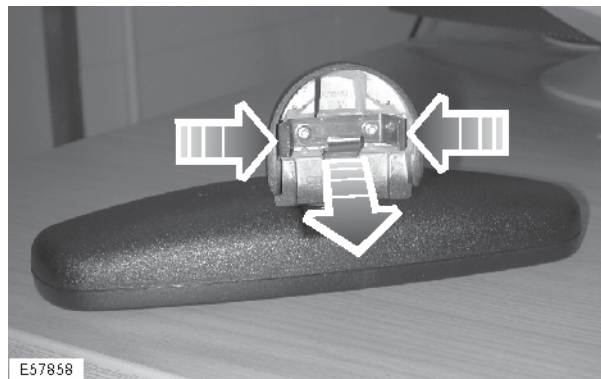
ILLUSTRATION 1

Some X-TYPE vehicles may exhibit a loose auto-dimming interior rear view mirror. This condition is caused by the retaining springs having become loose or misaligned to the mirror base.

ADJUSTMENT OF RETAINING SPRINGS

1. Remove the auto-dimming interior rear view mirror (see Global Technical Reference Workshop Manual, section: 501-09, SRO 76.10.56).
2. Adjust the two outward springs inwards, and the single spring forwards (Illustration 1).
